MEMORANDUM

DATE:	May 2 nd , 2016
FROM:	Eric Lancaster
SUBJECT:	Weekly Progress Report @ Gold King
TO:	Steven Way

Project: Gold King Interim Water Treatment Plant (IWTP)
Location: Gladstone, Colorado
Prepared for: Emergency Response Unit – US EPA Region 8

Reporting Period: Apr 25 – May 2
Report No.: 19

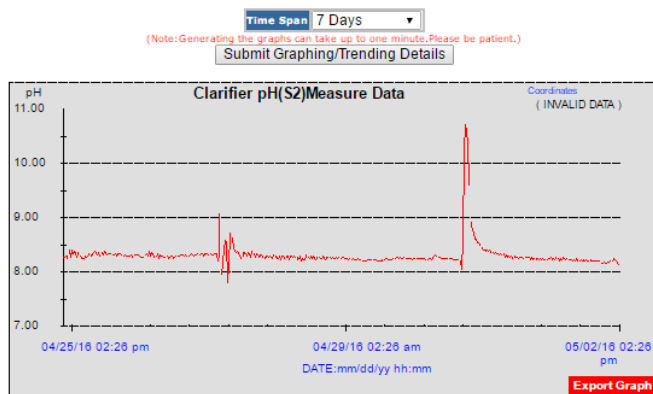
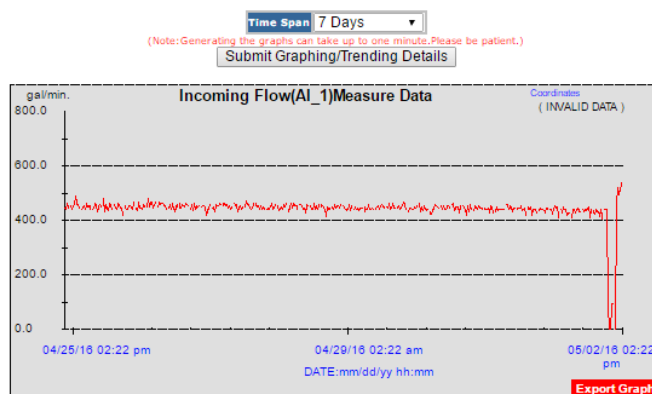
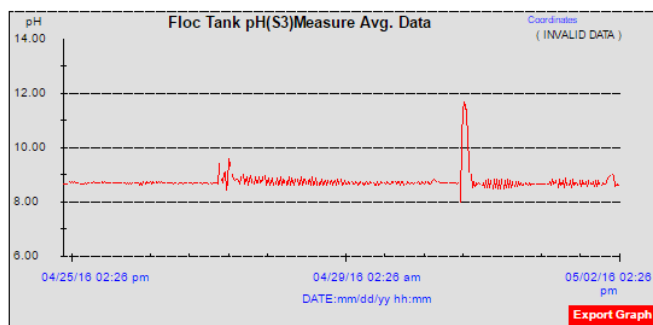
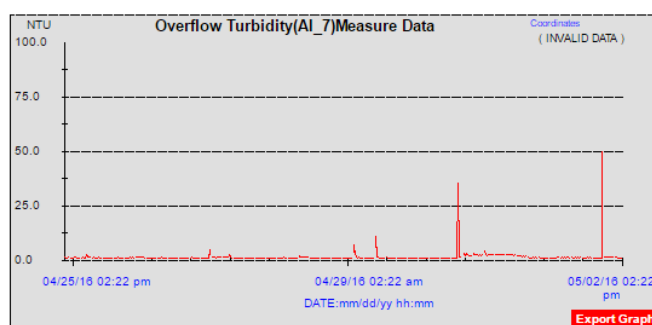
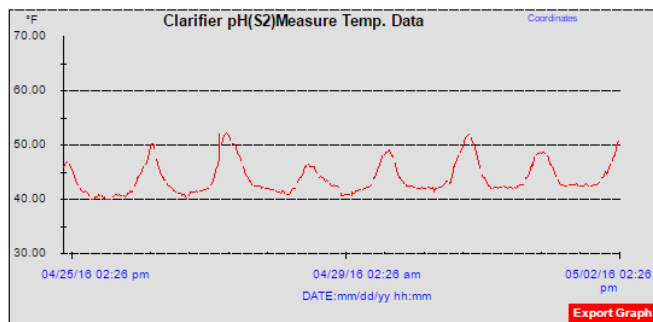
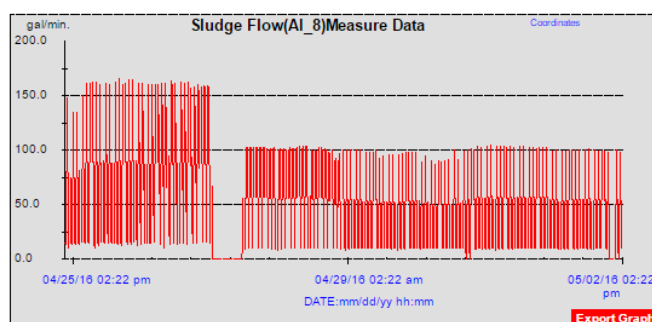
- The following graphs provide trending information during the previous 7 days. The dataloggers collect control information from the Lime Circuit (left) and Flow Circuit (right) Programmable Logic Controllers (PLCs) at the Gold King IWTP. Over the reporting period (4/25/16 – 5/2/16 inclusive) Alexco treated 4.38 million gallons at an average flow rate of 435 gpm with all discharged treated water leaving the 12" HDPE pipeline.

- Please note: Several days each week, the Alexco operators check the pH at both the flocculation tank and clarifier discharge. During this time, the probe is placed in vinegar (acid), and three pH buffers – 4, 7, and 10. While the probe is in the acid/buffer, the datalogger may capture one of those points for tracking purposes, which explains the occasional pH spikes seen on the graph.

- On 4/30, the Alexco operator transferred lime from the horizontal silo to the vertical silo. Normally, the Vibrascrew Feeder is turned-off at that time because pressure within the vertical silo forces additional hydrated lime powder into the lime slurry tank. This did happen and a thick batch of lime slurry was made. This caused the peristaltic pumps to overshoot temporarily and caused a short spike in pH.

- On 5/2, the Alexco operator closed the incoming butterfly valves and slowed flow to roughly 100 gpm. This was done during the electrical upgrade, when devices were removed from one panel and connected to the new panel.

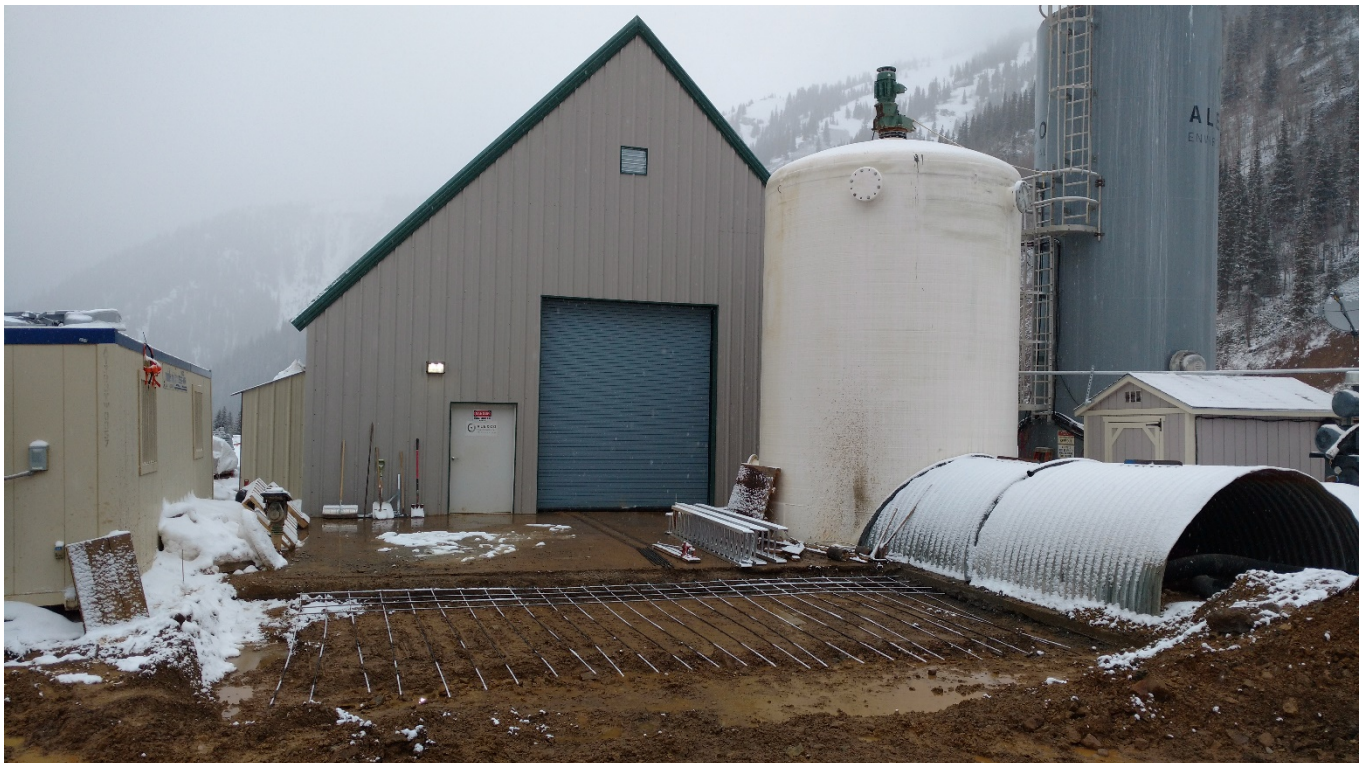
Photo 2: Preparing the pour for the 2nd clarifier – Taken on 4/26/2016

- **Spring Melt Contingency Updates:**
 - **Second Clarifier** – Alexco has received written notice to move forward with the installation/operation of a rental clarifier and supporting infrastructure required for spring melt. Alexco is targeting operation of this expanded system by May 10th.
 - **Additional Bags** – Alexco has additional textile bags (2X 125' x 45 and 1X 90' x 45') located at site that can contain an additional 2,000 CY of sludge. Alexco is able to install one or two of these additional textile bags as needed during spring melt.

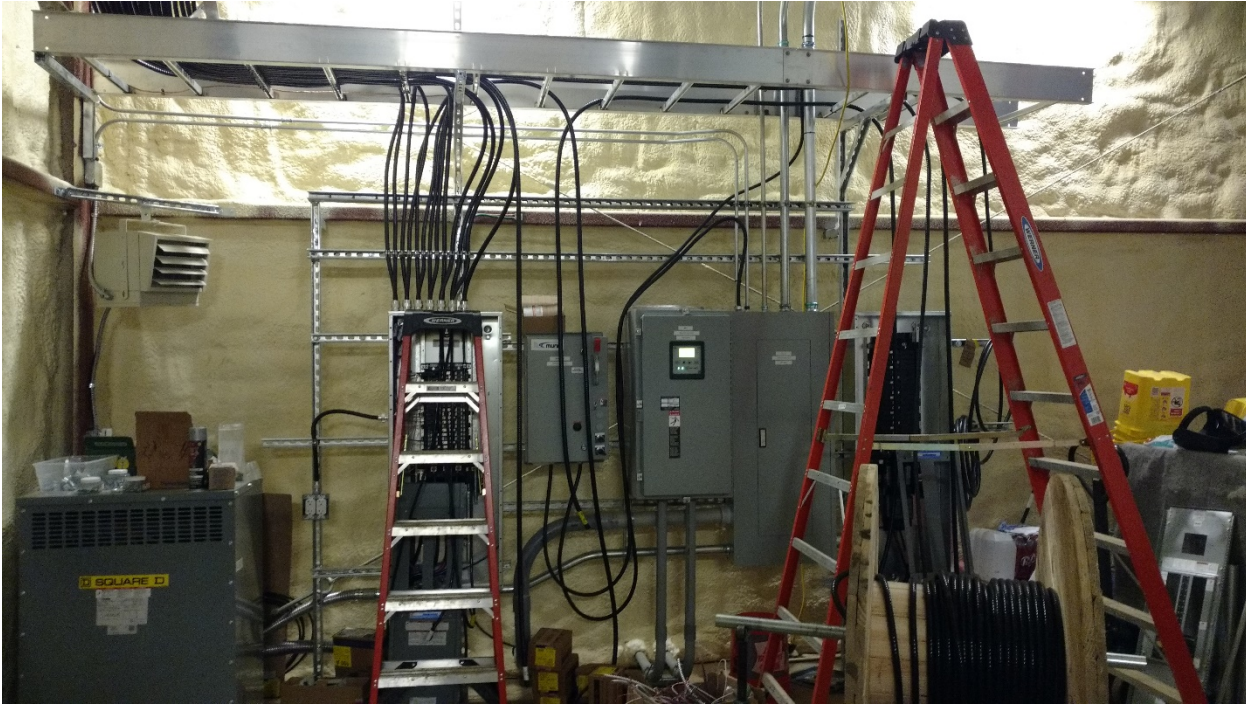
Photo 3: Upgrades to the electrical system for the upcoming inspection – Taken on 4/26/2016

- **Electrical Upgrades** – Alexco's selected electrical contractor (Rapid Energy) began electrical upgrades on Friday, April 15th. These improvements will allow the IWTP to pass a final electrical inspection by the State Inspector. That final inspection is scheduled for Wednesday, May 4th.

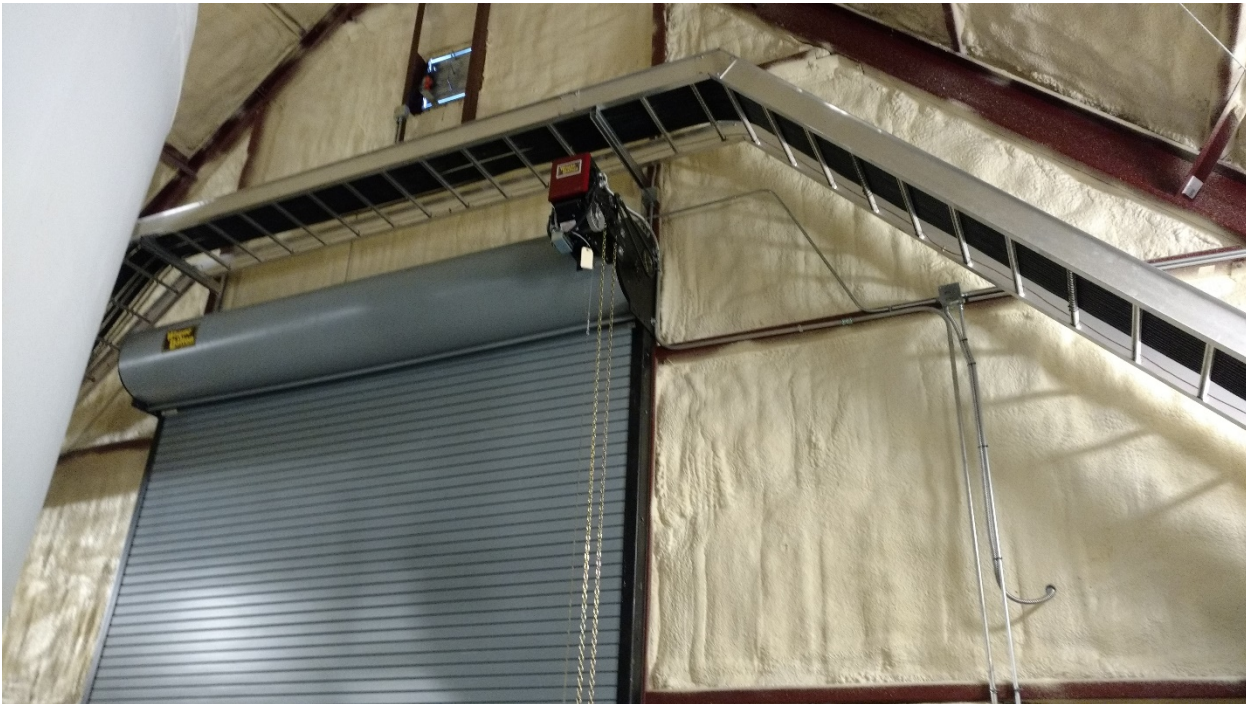
Photo 4: Cable tray installed over the door and throughout the building – Taken on 4/26/2016
